BSEE: Prevent fires by inspecting cords, plugs and welding leads before use

Safety Flash Published on 11 June 2026 Generated on 11 June 2026 IMCA SF 11/26

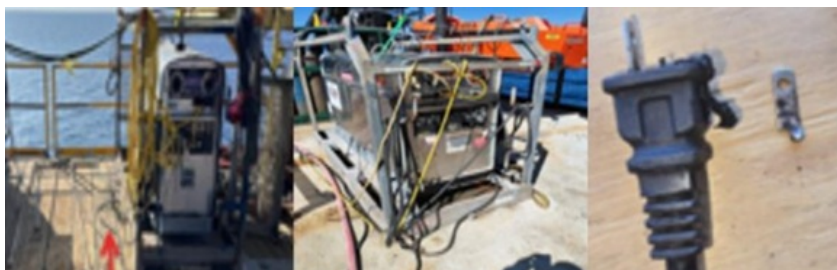
Incident 1: While walking past a welding machine, a worker saw the ground wire and plastic insulation on the welding lead melting. The worker immediately activated the machine's emergency shutdown to prevent further damage and reduce the risk of injury. During the follow-up inspection, an extension cord was found plugged into the machine that ran into the well bay area, along with the welding lead. A safety team member then doused the affected wires with water. The crew remained on standby and monitored the ground wire and welding lead to ensure the situation was stable and no further problems developed. BSEE note: Applying water to potentially live (energized) conductors create a serious electrocution hazard and may spread a fire if the conductors remain energized.

Incident 2: During routine construction operations, personnel noticed flickering at an electrical cord connection. At first, it appeared the light inside the clear head connection was flickering. Small flames then appeared at the side of the plug. Personnel told the welder to stop working, and as the welder turned to inspect the cord, it began to smoke. Personnel quickly unplugged the cord from the welding machine. They red-tagged the cord and removed it from service. They also inspected all other cords for visible damage and found no other problems.

Incident 3: Instrumentation and electrical crews connected their "Rothenberger Tubing Bender" to bend one-inch (2.5cm) tubing for two sample sinks. When they plugged it in, they saw the plug begin to melt. They quickly unplugged the equipment and notified platform management. An investigation found that the platform receptacle and extension cord were not the source of the problem. Instead, the tubing bender plug had a loose prong that was not detected during the pre-job inspection. The prong fell onto the workbench when the plug was removed. The tubing bender was taken out of service. This incident underscores the need to

verify plug integrity and prong security during equipment inspections, not just the condition of the cord and receptacle.

Contributing factors in all three incidents include inadequate inspections and equipment failure.

- Ensure extension cords, plugs, and welding leads comply with appropriate local legislation and industry best practice for electrical safety.
- Ensure that extension cords, plugs, and welding leads are all correctly rated for what they are being used for.

- Ensure all cords are three-wire types with intact grounding conductors and secure terminations. Inspect cords, plug prongs, strain reliefs, and terminations before each use.

- Limit extension cord length and regularly inspect, tag, and replace cords used to transmit power in accordance with company procedures and industry best practice.

- Conduct regular hazard hunts that include a check for proper use of extension cords, plugs, and welding leads.
- Confirm proper separation of extension cords, plugs and welding leads before work begins to prevent abrasion and abnormal wear of their protective sheathes/coatings.

- Follow permit-to-work and job safety analysis requirements to identify and assess electrical hazards before work begins.
- Ensure personnel performing electrical work or operating welding equipment are trained and competent in recognizing electrical hazards, including hazards involving temporary equipment.
