IMCA Safety Flash 08/17

April 2017

1 Serious Finger Injury: Procedures During Engine Maintenance

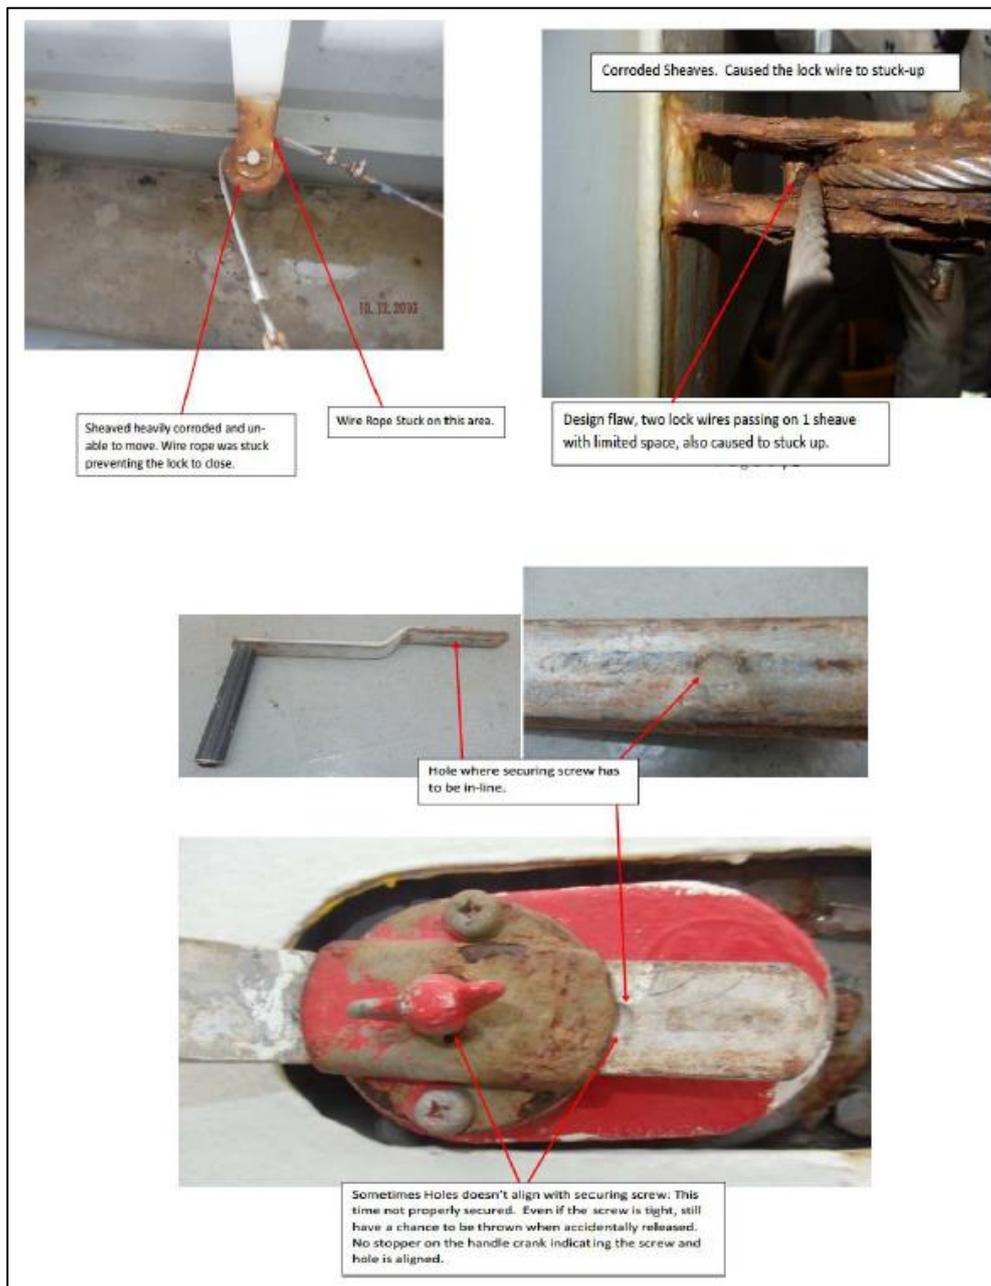
- ◆ There were a number of **immediate causes**:
 - the emergency release lever was in the wrong position
 - the safety locks were stuck open due to a rusted sheave trapping the wires

- the shallow indentation and wingnut screw used to secure the handle was inadequate;
- ◆ **Causal factors** that were identified:
 - lack of experience and knowledge: The Cadet did not trust his initial judgment that the flap was closed and followed the instruction to keep turning. A more experience crewmember may have been more confident to trust his instinct. He was not aware of proper position of the emergency release and was confused by the instructions painted above

- inadequate planning and procedures, inadequate maintenance and design of equipment;

- ◆ **Root causes** identified:
 - risk was not fully assessed or understood and was considered tolerable
 - instructions and warnings were unclear and confusing
 - maintenance of the wires, sheaves, winches locks and handles was not adequate
 - the securing mechanism for the crank handle was poor and left the handle inadequately secured;
- ◆ The **preventative action** taken was to:
 - prepare training in this operation
 - develop a risk assessment including minimum crewing required to do the task safely
 - appropriate maintenance and repair of the wires, sheaves, winches locks and handles
 - Ensure instructions are correct.
