IMCA Safety Flash 05/17

March 2017

Focus: Diving Safety

3 Bailout Cylinder and Pillar Valve Compatibility Failure

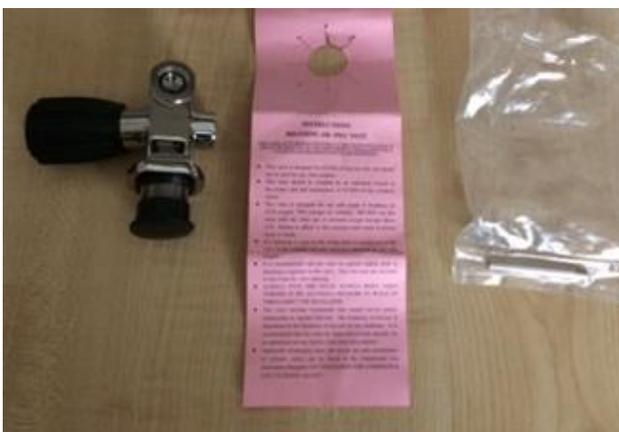
Attached are photographs of both the six pillar valves which failed during the original test and two other, order replacement pillar valves which also failed the test. Also attached are photos of a new pillar valve with packaging and demonstration photos of successful & unsuccessful GO thread gauge tests.

New Pillar Valve with Packing

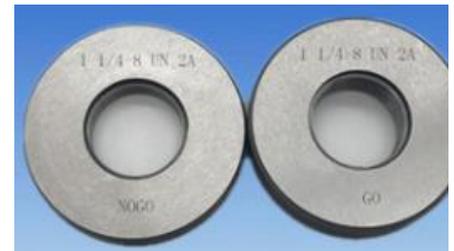
GO or NO-GO thread ring gauge

A thread RING gauge is used to check the accuracy of an outside thread.

The GO thread ring gauge should easily and completely slide over the outside thread. The NO-GO thread ring gauge should not be able to slide over more than 3 threads, if it does the outside thread is too small.

- ◆ It is recommended that organisations using Bailout Cylinders:
 - establish a planned maintenance system procedure whereby on all 6 monthly internal visual inspections the cylinder and pillar valve threads are checked using the GO/NO-GO thread gauges
 - ensure that cylinders and pillar valves are checked when purchased and before putting into service to ensure correct fitting using calibrated GO/NO-GO thread gauge and by a trained technician
 - implement a method of marking the pillar valves so that a register can be created to record or link a particular pillar valve to a particular cylinder by serial number.

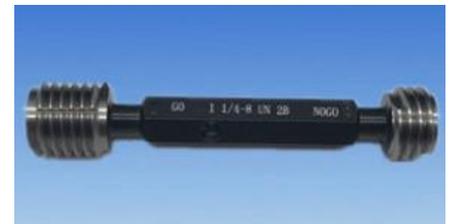
GO or NO-GO thread plug gauge

A thread PLUG gauge is used to check the accuracy of a threaded hole.
