IMCA Safety Flashes summarise key safety matters and incidents, allowing lessons to be more easily learnt for the benefit of all. The effectiveness of the IMCA Safety Flash system depends on Members sharing information and so avoiding repeat incidents. Please consider adding safetyreports@imca-int.com to your internal distribution list for safety alerts or manually submitting information on incidents you consider may be relevant. All information is anonymised or sanitised, as appropriate.

1 American P&I Club: unfamiliarity with semi-portable fire extinguishers

2 Lifejacket battery caught fire

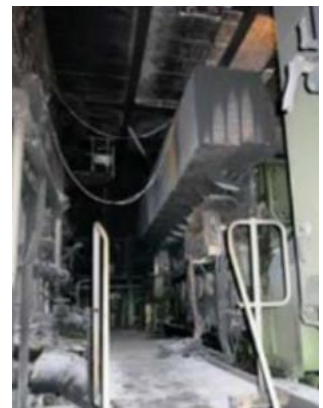
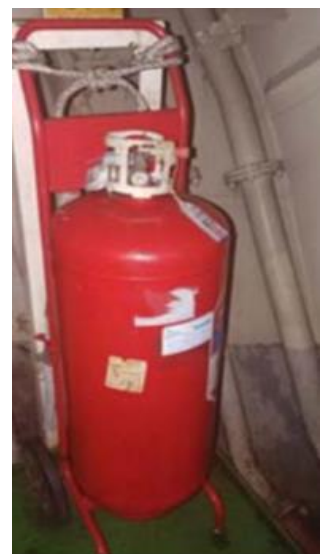
A generator in a ship underway experienced a catastrophic failure, resulting in a fire in the bilges. The two engineers in the engine room heard a loud bang, investigated and saw the fire. The senior engineer saw the fire was in the bilges and knew that the semi-portable foam fire extinguisher was appropriate to use. He sent the junior engineer to it with instructions to activate it and use it to fight the fire.

The junior engineer was unfamiliar with the operation of the semi-portable foam fire extinguisher and did not really know how to operate it. The delay of several minutes thus caused, allowed fire and smoke to spread. The engineers were forced to evacuate. The bridge sounded the general alarm and the crew were mustered. Once the engineers were accounted for, the engine room was isolated and the fixed CO₂ system was triggered to put out the fire.

The fire caused damage in excess of US\$250,000. Had the fire been quickly extinguished, the damage would have been substantially less.

- Ensure crew members are properly trained and ensure they are familiar with the **specific** fire extinguishers and fire extinguishing systems on the vessel;
- Hold frequent training and drills to ensure that the excitement and adrenaline surge that happens during an emergency do not lead to delays or prevent appropriate actions from being taken.
