1 LTI: Diver suffered crush injury to finger

2 High potential incident - Foot trapped under ram cylinder

3 Fall leading to serious personal injury

4 Chemical burns to body

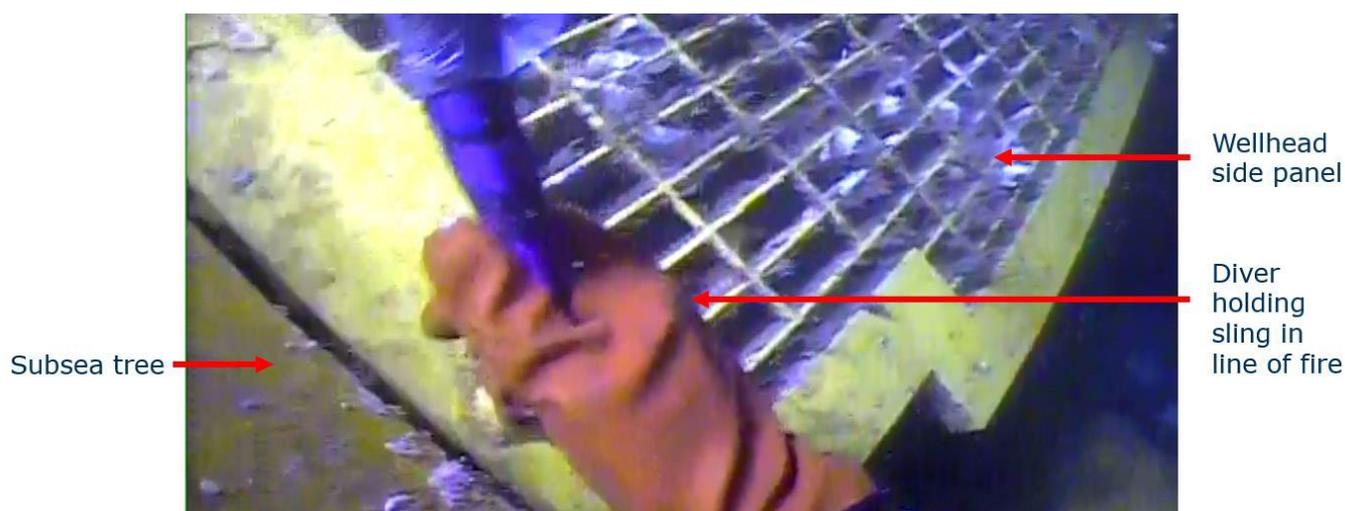
A diver sustained a crush injury to his finger. The incident occurred when a diving support vessel was working on a decommissioning project, and the dive team were working to re-instate a side panel on a subsea tree. The task was carried out by using the vessel main crane in active heave compensation mode, with the divers required to position the panel into the tree hinges. While the diver's hand was positioned between the panel and the tree, the vessel heaved, causing movement on the panel, causing the diver's finger to be crushed between the panel and the tree.

The diver sustained a fracture and laceration to his right-hand ring finger, resulting in an LTI.

The diver was holding the sling too close to the panel, meaning that when the vessel heaved, his hand was in the line of fire;

While pinch points were identified as a hazard, no specific measures (i.e., use of tag lines) had been implemented to suitably control the hazard;

While the procedure allowed for two methods of completing the task (either through the use of the crane or the use of lift bags) there was no guidance or instruction on factors to consider when deciding on which method to use.

When moving loads, wherever possible pinch point hazards should be eliminated by use of 'hands-off' lifting techniques:

Where it is not possible or advisable to use 'hands-off' lifting techniques, the task risk assessment should be reviewed and updated to outline how the pinch point hazard will be managed and controlled;

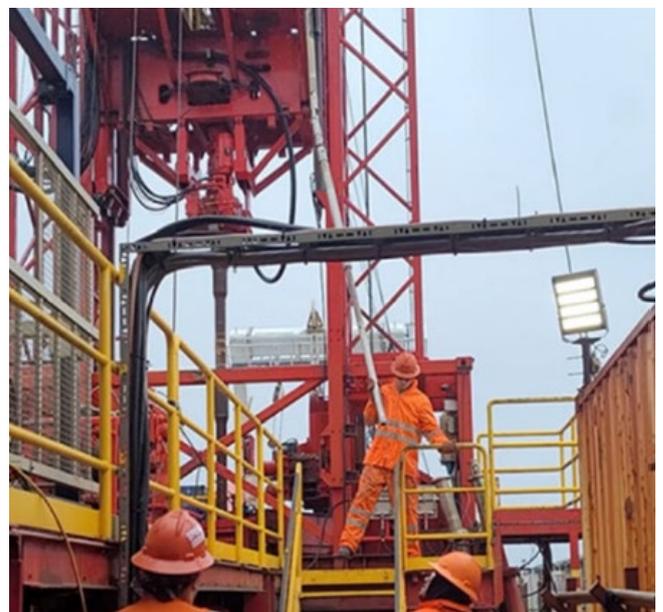
A crew member suffered a fall leading to concussion and other serious injuries. The incident happened when he was single-handedly trying to hold and manoeuvre a drill tool into position for a certain task. The movement of the vessel combined with slippery conditions underfoot meant that he lost control of the swinging tool, which caused him to fall onto the raised platform floor/deck. He was concussed and sustained various soft tissue injuries.

The potential implications of the mixed sea conditions (operating in marginal (but within defined working limits) sea state for drilling operations), damp equipment and slippery deck (due to foggy conditions) were not sufficiently considered or mitigated in the task risk assessment and planning;
