1 Diver Finger Injury – Scrubber Blower Fan

2 BSEE: Unsecured Pressurized Hoses Result in Hand Injuries

3 Cook's arm scalded while removing food from oven

4 LTI: fractured finger during anchor handling

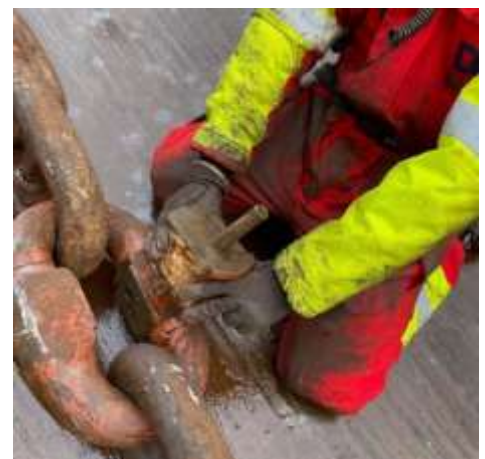
The injured person was sitting on deck hitting the Kenter heart down to drive out the pin. The pin is a conical shape, and so it must be done the correct way or else it will be driven firmer into the Kenter heart. If this is done the correct way, the pin comes out easily. While he was hitting the heart with the pin down to a hard surface the wrong way, it didn’t loosen but slipped and his finger got squeezed/pinched between the deck/chain and Kenter heart.

- Lack of training & knowledge – the injured person had previous experience on deck on various vessels, but was new to this vessel and anchor handling operations. While he had received training and he was supervised working on the aft deck. He did not know about the conic shape of the pin in the Kenter heart.
