IMCA Safety Flashes summarise key safety matters and incidents, allowing lessons to be more easily learnt for the benefit of all. The effectiveness of the IMCA Safety Flash system depends on members sharing information and so avoiding repeat incidents. Please consider adding safetyreports@imca-int.com to your internal distribution list for safety alerts or manually submitting information on incidents you consider may be relevant. All information is anonymised or sanitised, as appropriate.

1 Diving instructor killed – incorrect valve threads (IDSA)

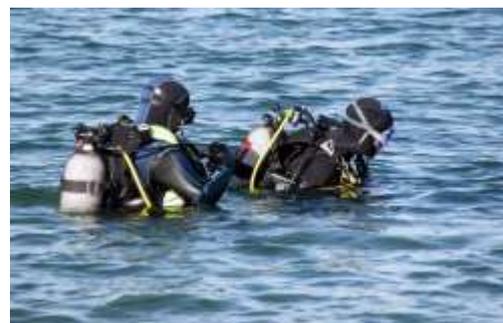
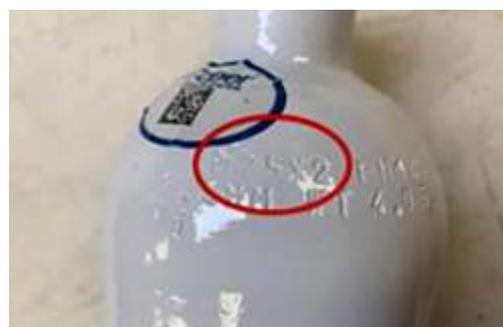
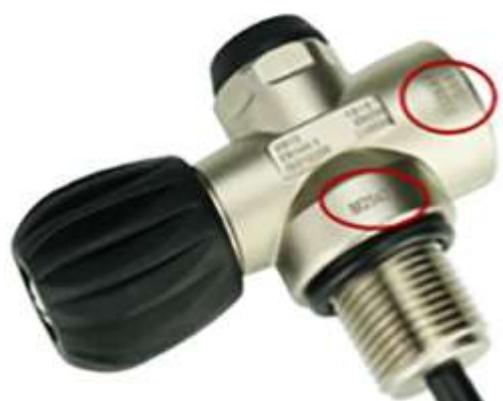
During a dive, the valve came loose from the diving cylinder and fatally hit the diving instructor; a cylinder with internal thread G3/4 was used, which was fitted with a valve with external thread M25x2.

Threads on the diving cylinder and the mounted valve were incompatible. In this case, the screw thread of the valve was slightly smaller than that of the screw thread in the diving cylinder. The result was that there was an increased risk that the valve will come loose from the cylinder when at pressure.
