2 Finger crushed under Tether Management System (TMS) protection guard

Engineering Advice Note (EAN) No. 183

URGENT SAFETY ADVICE - TMS8 SIDE PROTECTION GUARDS

3 Sudden and uncontrollable move of A&R head

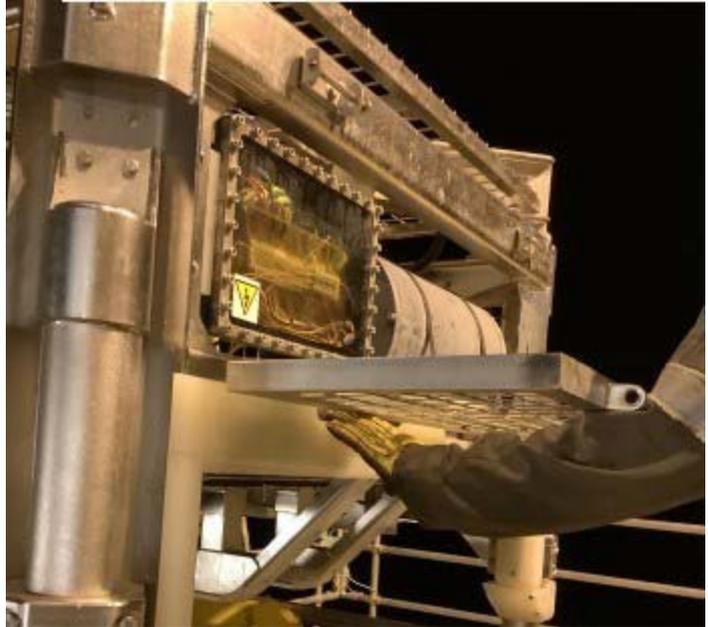
A worker suffered a crushed finger when the protection guard of a Saab Seaeye TMS8 Tether Management System fell on their finger. The worker was closing and securing the protection guard and lost grip on the guard. The guard fell down and trapped the left ring fingertip between the guard and the TMS frame. Upon removal of the glove it was identified the fingertip was damaged. The injured person went straight to the medic, who verified that the injury warranted hospitalisation, and the injured person was taken to hospital onshore.

- With the two top pins removed the TMS guard can fall down if not safely supported – as when grip is lost;
- It was cold; there was no weather protection – cold hands;
- The worker was keen to complete the task in hand;
- The worker was not wearing the correct type of gloves;
- The task not fully risk assessed; there was no specific procedure/training to follow for guard removal.
