1 Differential pressure: dummy choke ejected close to divers

2 Crane boom stopper fell to main deck

3 Fire alarm activation in engine room

5 Close approach of AHTS vessel to offshore rig

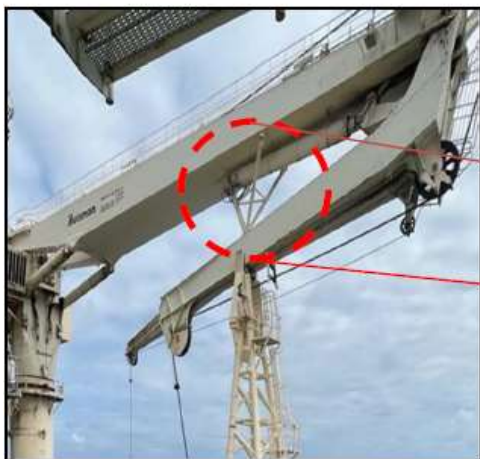
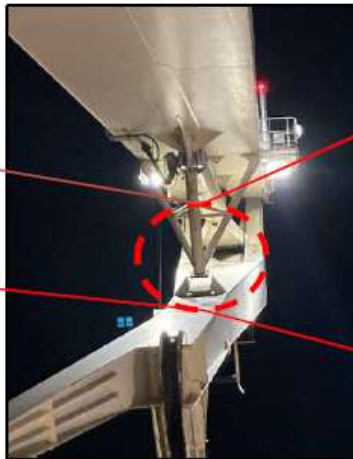
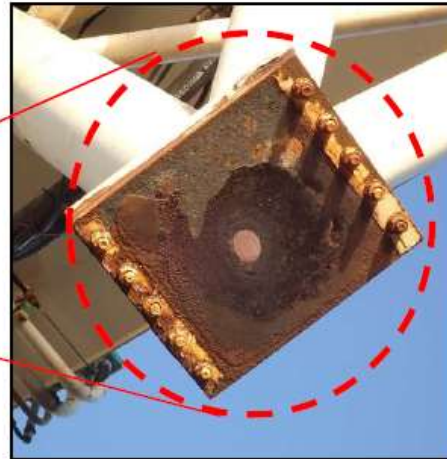
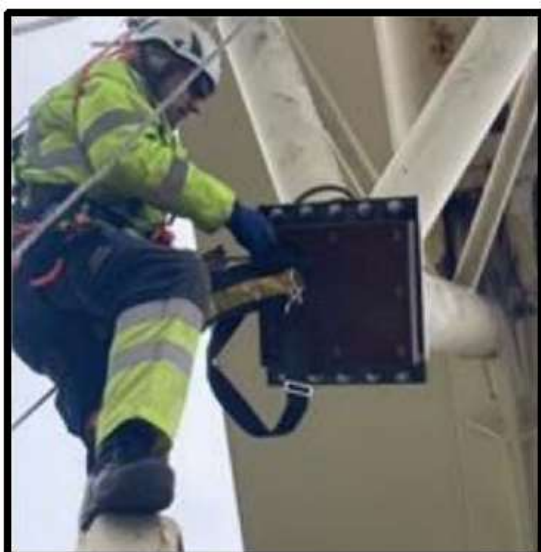
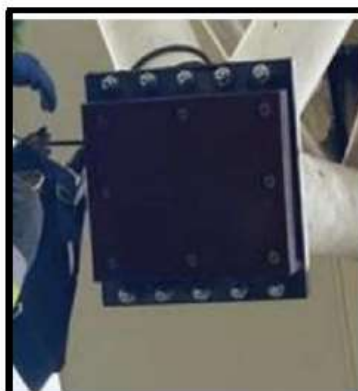
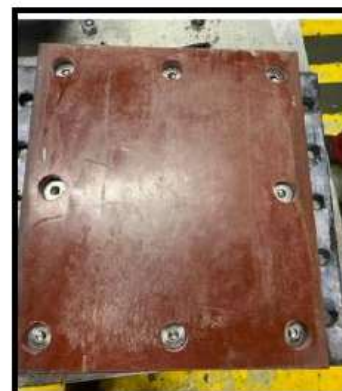
Knuckle boom pad

- There is potential for similar incidents to happen on other vessels, in areas where access to potential dropped objects is difficult. Check and see:
 - If any other cranes use the same or similar type pads and if so, ensure alternative or additional fixings are applied to any connections solely reliant on adhesive compound bonding;

- Identify equipment and structures that present a risk of dropped objects and cannot be easily accessed for inspection and determine the best means of safe access and an appropriate frequency of inspection;
- Verify if there is an existing work order or dropped object check list to cover these items and add/update as necessary.
