1 Three crane incidents

2 Finger trapped and injured while working on heavy equipment

3 Machinery damaged through improper maintenance technique

4 Gangway damaged after unauthorised re-installation

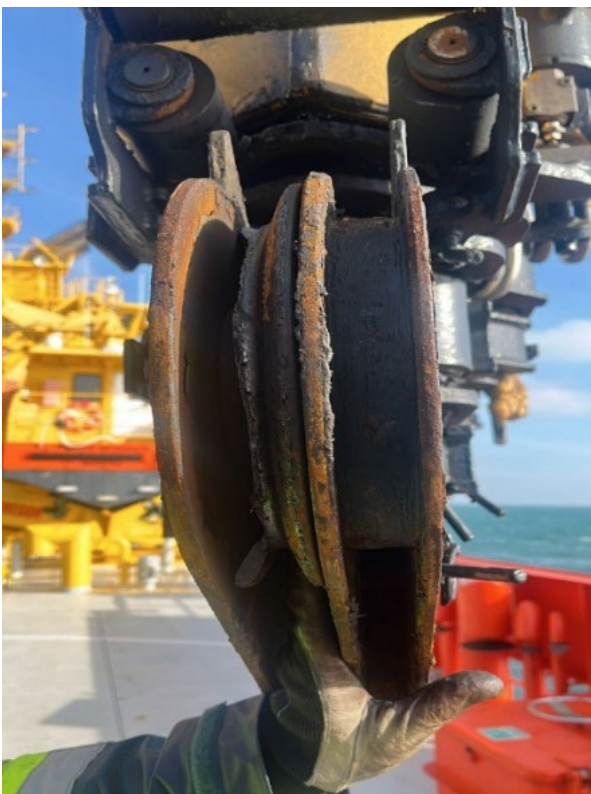
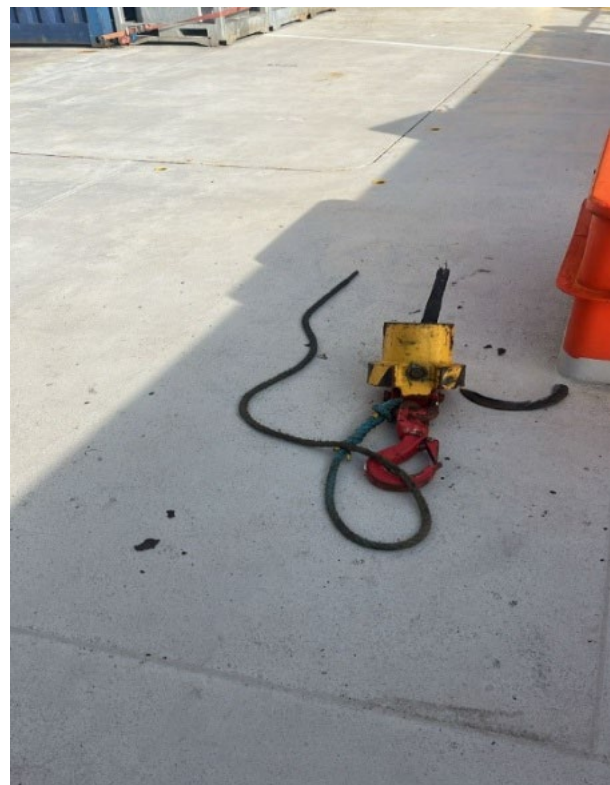
Incident 1: wire and pulley damaged

Whilst a crane was being parked after use, the crane operator unintentionally pulled out the telescopic boom while the hook block was fully retracted and secured in its resting position. As a result of extending the telescope without releasing or lowering the hook, excessive tension was applied to the wire rope and pulley system. This caused overloading of the wire and sheave assembly, leading to breakage of the wire rope and damage to the pulley.

- **Correct procedure not followed:** The required parking sequence, which was to fold the knuckle first, and then lower the boom, was not followed. Instead, the operator extended the telescopic boom while the

hook block was fully retracted and secured, pulling the hook into the fairlead and overstressing the wire until it parted.

- **Lack of situational awareness:** The operator selected the wrong function, extending the boom rather than folding and lowering it. This unintended movement, combined with the nearly retracted boom, generated excessive tension and led to the wire rope and pulley failure.

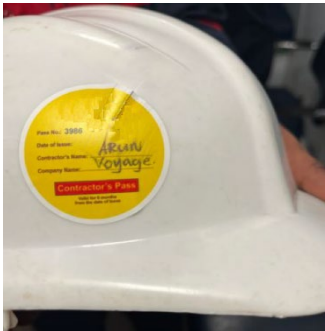
Controlled Contractor Induction Process

A centralized induction process ensures all contractors working on a vessel or at a site, are properly briefed before starting work. Upon completion, they receive clearly identifiable induction stickers for easy verification on site. This strengthens compliance, enhances safety, and demonstrates commitment to a well-controlled working environment.

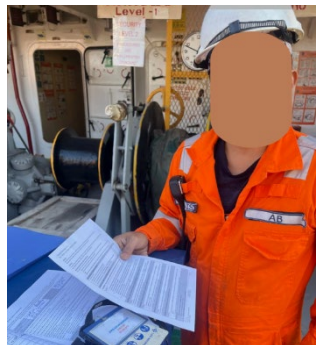
Effective Gangway Induction and Documentation Control

On a vessel alongside, crew demonstrated a high standard of safety awareness by effectively delivering visitor induction at the gangway. Relevant policies, procedures, and induction checklists were readily available and properly maintained at the gangway station. This ensured that personnel boarding the vessel could be briefed on safety requirements and vessel rules prior to access, supporting strong access control and promoting a safe working environment onboard.

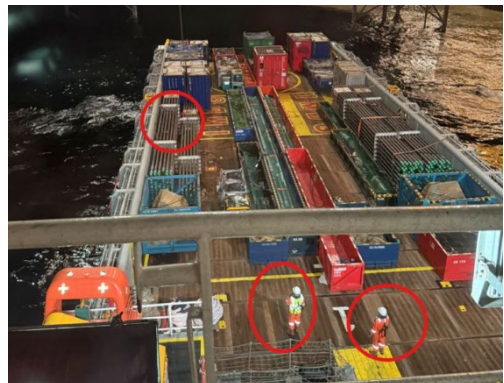
Safe Positioning and Good Communication During Lifting Operations

Lifting crew maintained a safe distance from moving cargo during deck lifting operations. Good use of hand tools was observed to guide the load and minimize potential cargo impact. This demonstrates strong safety awareness and adherence to safe lifting practices.
