Fire in the engine room – fuel spray fire

Safety Flash Published on 4 December 2025 Generated on 4 December 2025 IMCA SF 22/25

A fire broke out on the starboard main engine due to a leak from the fuel pipe connection.

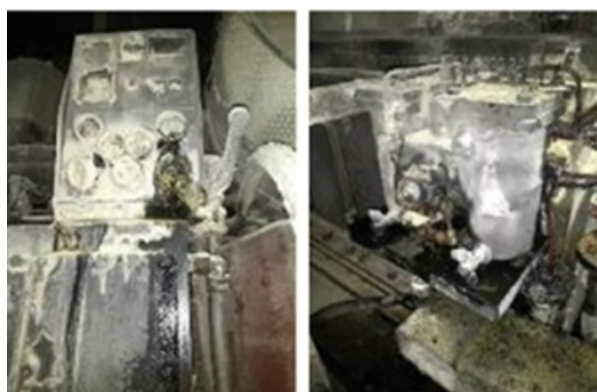
A fire broke out on the starboard main engine due to a leak from the fuel pipe connection, which allowed fuel to be sprayed out onto hot engine surfaces. Although the fire was quickly extinguished by the crew and no injuries or pollution occurred, the incident highlighted a serious lapse in fuel line protective barriers and fire prevention measures.

- After recent maintenance, bolts for a fuel return pipe were not reinstalled. This was the cause of the leakage.
- The protective cover of the injection pump and the fuel line was not refitted after maintenance.
- There was no anti-splashing tape applied on fuel lines near hot surfaces.
- The water mist system did not activate because its power supply was OFF.
- The quick-closing valves and emergency stop were activated late, showing that crew awareness of critical system timing could have been better.

- Always check after maintenance that all bolts, fittings, and covers (if fitted) are reinstalled. Create a check-list; use a check-list.
- Protective covers or Anti-splash tape should be fitted on exposed fuel pipes/joints near hot surfaces and should be replaced if missing or damaged; never leave them uncovered.
- Ensure safety equipment such as water mist systems, quick-closing valves and emergency stops, are in good working condition and that all crew are fully familiar with how safety equipment should be operated.
