## Unauthorised firing of rocket line

Safety Flash    Published on 10 September 2026    Generated on 11 September 2026    IMCA SF 16/26

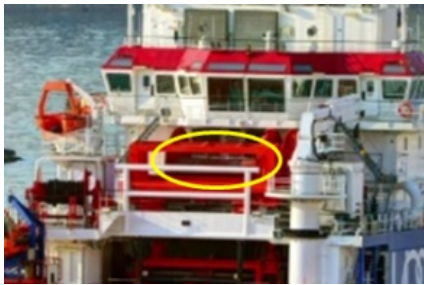
Without warning or agreement, Line Throwing Apparatus (LTA) was discharged by the tanker deck crew, splitting into two parts. The apparatus malfunctioned; one part of the rocket struck the upper spooling winch, the line detached and returned to deck.

*Yellow circle – where rocket struck*

- **Better ways of working together:**
  - A mandatory pre-transfer checklist should be signed by both vessels
  - Clear communication protocols and procedural compliance verification are critical for safe operations
  - Pre-job planning and confirmation of methods reduce risk of unsafe acts and behaviours
- **Stop-work authority** is effective in preventing escalation.
- Check equipment to make sure it works, and/or to make sure it is still “in date”.
